TOWN OF OCEAN VIEW
DELAWARE

SUBJECT: Monthly Update for the Dept. of Planning, Zoning & Development as of November 3, 2022

RE: Hunter's Run Drainage Evaluation
Town of Ocean View, Delaware
Contract No. OV21-0001, Task 12
WM No.: 220024.0012

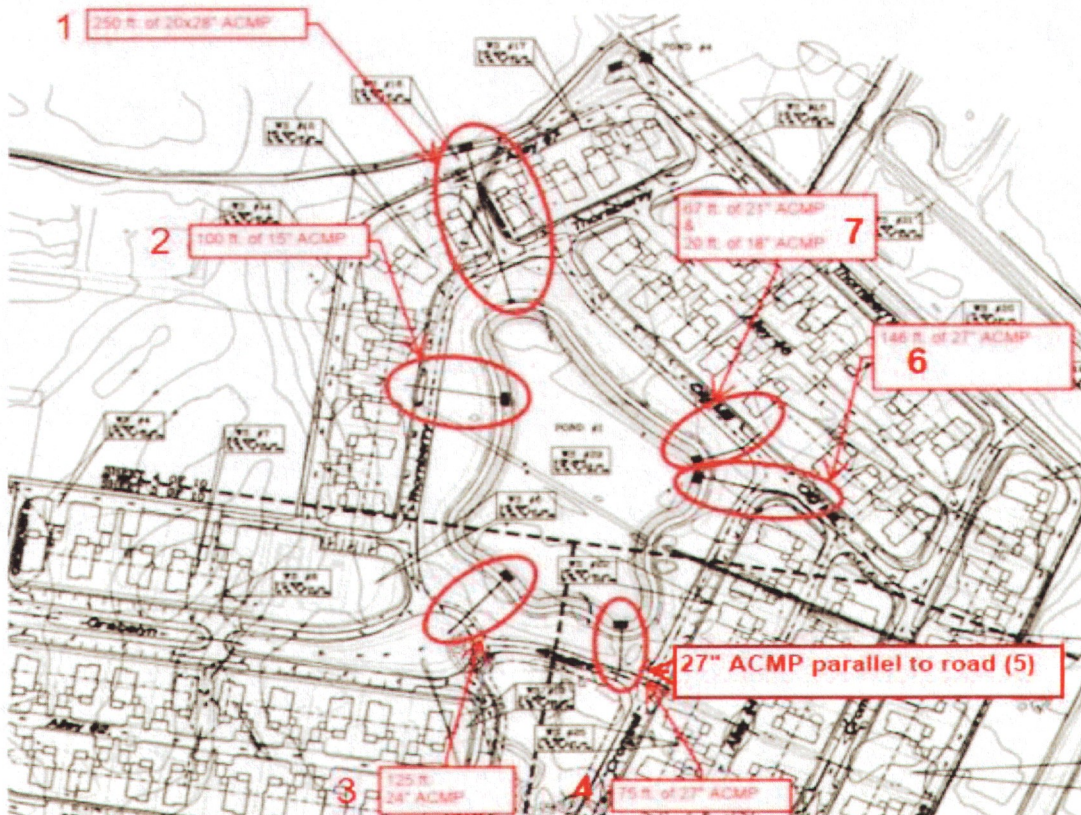
Wallace Montgomery (WM) is pleased to submit this drainage evaluation for the Town of Ocean View (Town) at the Hunter's Run Community Stormwater Facility. We performed a physical and video (scoping) condition inspection of four (4) asphalt-coated corrugated metal pipes (ACMP) on September 13, 2022. The inspections were performed by Standard Pipe Services, LLC (SPS) and David LaBella, PE of WM. Since the diameters and length of these pipes are very small and inaccessible for a hands-on inspection (HOI), we utilized SPS to clean and video scope the pipes to ascertain a more detailed and accurate depiction of the structure condition. The project area is shown below and in Photo 1.
