Study Background/Overview

- Traffic Engineering Services Task 6 involving a traffic study for Ogre Road in the Town of Oceanview
- Ogre Drive is an approximately 0.6-mile north-south municipal maintained road within the Oceanview Estates Development with 15 mph posted speed
- Ogre Drive intersects with West Avenue/Muddy Neck Road (S361) at the south end & W Riga Drive at the north end
- This study aims to address speeding issues and potential traffic calming measures
- It involves obtaining vehicular speed, vehicular volumes (vehicles per hour [vph]), average daily traffic (ADT vehicles per day, [vpd]) and vehicle classification for the purpose of addressing the problems
 - Ascertain whether potential cut-through traffic is a problem

Ogre Drive Speed & Traffic Calming Study, Ocean View, DE Location Map

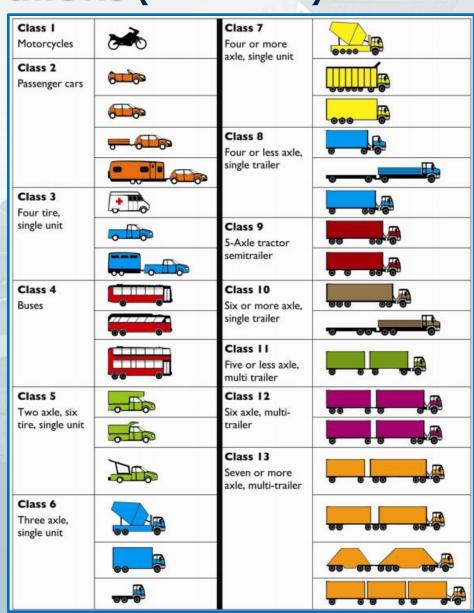
- ► Federal Highway Administration (FHWA) 13 vehicle category classification as illustrated on the next page was used
- Study Period 1 (Average Conditions)
 - **■** ADT = 222 vpd
 - Highest peak hour volumes: 19 veh/hr from 11:00 a.m. to 12:00 p.m. and 19 veh/hr from 4:00 p.m. to 5:00 p.m (typical two clearly defined peaks for residential)
 - Ogre Road is not a high-volume road

- Study Period 1 (continued):
 - **■** Bikes, cars & trailers = 75% of all vehicles
 - **■** 99% of all vehicles fall in the Class 1 to 5 category
 - Ogre Road is not a high truck volume road
- Study Period 2 (Summer):
 - **►** ADT = 444 vpd (double average ADT)
 - Highest peak hour volumes: 38 veh/hr from 11:00 a.m. to 12:00 p.m. and 36 veh/hr from 12:00 p.m. to 1:00 p.m (atypical midday peaking)
 - Ogre Road is not a high-volume road
 - **■** Bikes, cars & trailers = 77% of all vehicles
 - 99% of all vehicles were within the Class 1 to 5 category
 - Ogre Road is not a high truck volume road

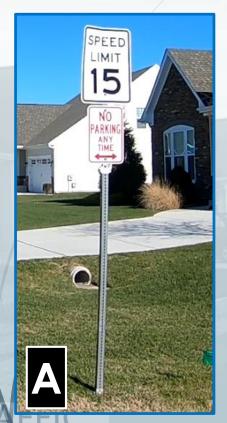
120 feet north of Muddy Neck Rd

- Existing roadway signing and their approximate locations documented on video in <u>December 2019</u> are presented on the following pages and include:
 - Two 15 mph Posted Speed Limit signs (R2-1) northbound & one southbound
 - Three "No Parking Any Time" signs (R7-1) northbound & two southbound
 - Two "Stop" signs (R1-1) each northbound southbound the northbound sign at Riga Drive has a very low mounting height

Northbound Ogre Drive (2019)

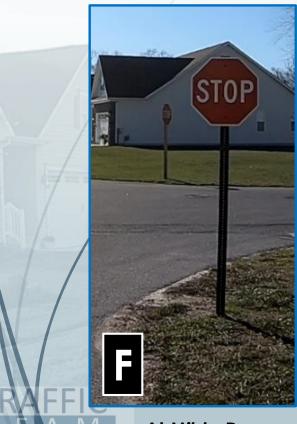
At Milda Dr

Southbound Ogre Drive (2019)

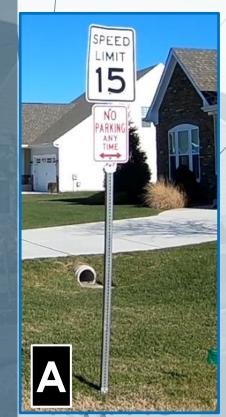
100 feet north of Muddy Neck Rd

- Existing roadway signing and their approximate locations documented on video in <u>August 2020</u> are the same as those documented in 2019 except:
 - "No Parking Any Time" sign "B" (northbound) and "H" (southbound) have been replaced with Radar Speed Signs
 - ► Northbound, a new "Now Leaving the Corporate Limits of Ocean View" sign (I-2-DE2) has been installed approximately 140' north of Velta Drive southbound
 - **■** Southbound, a new "Entering the Corporate Limits of Ocean View" sign (I-2-DE1) has been installed approximately 110' south of Milda Drive southbound
 - Northbound, the speed Limit sign at Milda Road on sign assembly "D" has been renewed/replaced to include a border
- The roadway signing as of <u>August 2020</u> are presented on the next two pages rand are generally adequate for a municipal road

Northbound Ogre Drive (2020)

- It is recommended that Option 1 traffic calming measures be implemented as follows to help reduce speed on Ogre drive to or below 15 mph:
 - Install a new 15-mph regulatory speed limit sign directly below the existing northbound radar speed sign located on the east side of Ogre Drive approximately 1175 feet from Muddy Neck Road.
 - ► Install a new 15-mph regulatory speed limit sign directly below the existing southbound radar speed sign located on the west side of Ogre Drive approximately 790 feet from Velta Drive.
- Install a new "Strictly Enforced" sign directly below the existing northbound speed limit sign located on the east side of Ogre
 Drive approximately 100 feet from Muddy Neck Road
 - Relocate existing "No Parking Sign" below the new sign

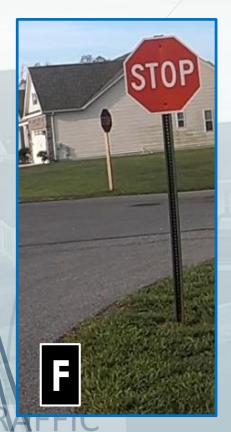
At Milda Dr

Southbound Ogre Drive (2020)

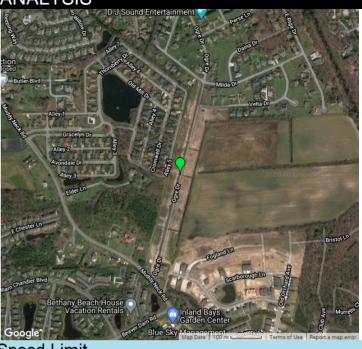
SPEED DATA ANALYSIS

Average Speed

19

85th Percentile Speed

24
